*River channel characteristics at
selected ice jam sites in Vermont*

Lawrence W. Gatto

October 1978

Prepared for
EMERGENCY OPERATIONS CENTER
U.S. ARMY ENGINEER DIVISION, NEW ENGLAND
By
COLD REGIONS RESEARCH AND ENGINEERING LABORATORY
U.S. ARMY CORPS OF ENGINEERS
HANOVER, NEW HAMPSHIRE

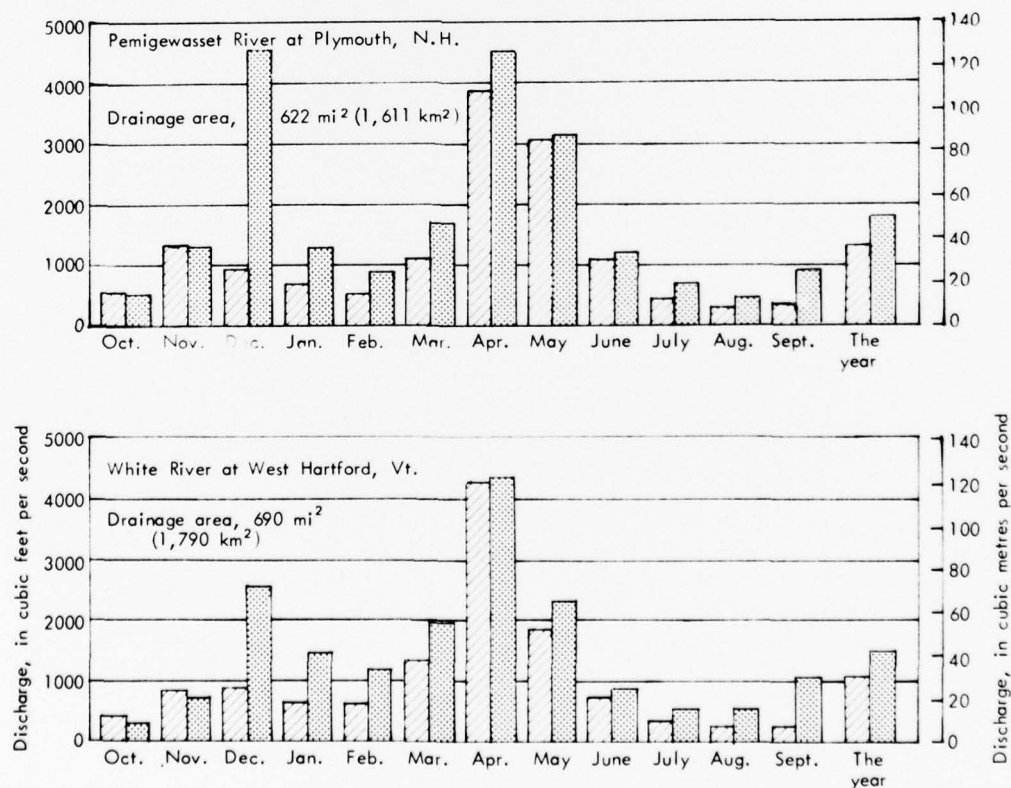
Figure 2. Median discharge at two long-term index gaging stations for period 1941-70 (U.S. Geological Survey 1974).

to February, then increases through March to April when it peaks and decreases to the August-September period. A stable ice cover generally forms during the decreasing discharge period from December through February; then this cover is broken and set in motion as discharge increases in March.

In retrospect, there are several reasons that the best time to acquire aerial photographs for this type of study would be in late October or early November. Based on the long-term flow data in Figure 2, flows at this time are comparable to those in February and March when jams usually begin to form. During the October-November period, the extents of riffles and pools could be easily observed and measured since water levels would be down. These features were apparent on the April photographs for only a few sites. In addition, most trees are bare at this time and would not obscure channel margins. Flying weather is usually good because atmospheric haze is low and cloud-free days are numerous. However, sun angle is decreasing during this period and shadows may mask portions of the channel margins that are bordered by trees. As DenHartog (1977) indicated, ideally aerial photographs should be taken twice: once when water levels are low and jams are absent to allow best observation of the channel so that possible obstructions to flow could be documented; and again, during increased flows after jams have formed to show where the ice was stopped and to suggest which obstruction may be the primary factor in initiating the jams.

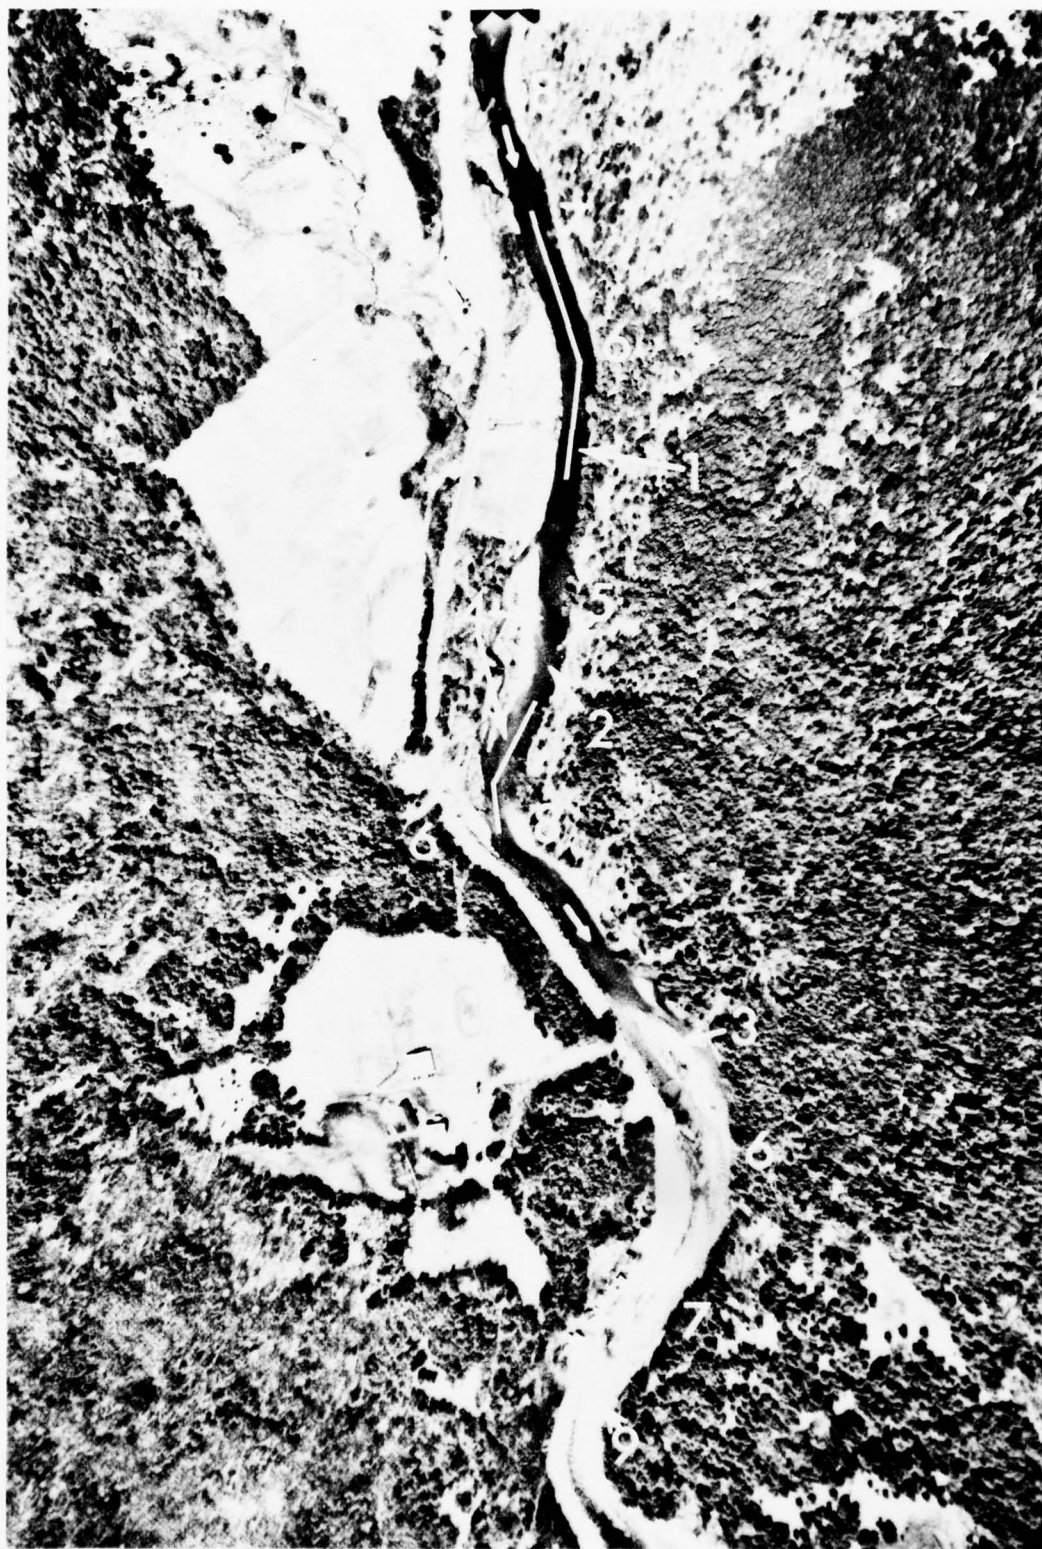
Figure 3. Waits River, upstream from Bradford site. Scale: 1 in. = 519 ft (north is upstream).

Figures 3-9 indicate how the features and conditions (Table III) observed at the various sites appeared on the original aerial photographs at full scale. Many of these features are shown in Figure 3. The other figures were selected to show the remaining features at different geographic settings. The dark, smooth appearance of the pool (1)† contrasts with the wavy lighter appearance of the riffle (2) (Fig. 3). Water depths are greater in the pools, but water velocities and surface roughness are generally less. The lighter appearance of the riffles results from a possible combination of increased bottom reflection and increased solar reflection due to water surface roughness. A large riffle (1 in Fig. 4) that extends across the Waits River is frequently the site of ice jams. Bed material here is coarse with exposed boulders (2) and cobbles (3). In Figure 3,

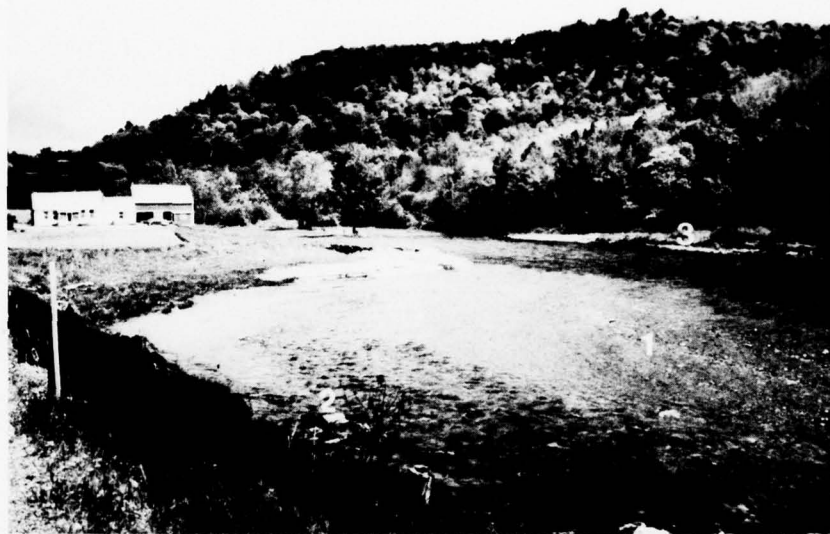
Figure 4. View upstream on Waits River from point 5 on photomosaic 12-13 (App. A). (Photo, courtesy of D. Calkins).

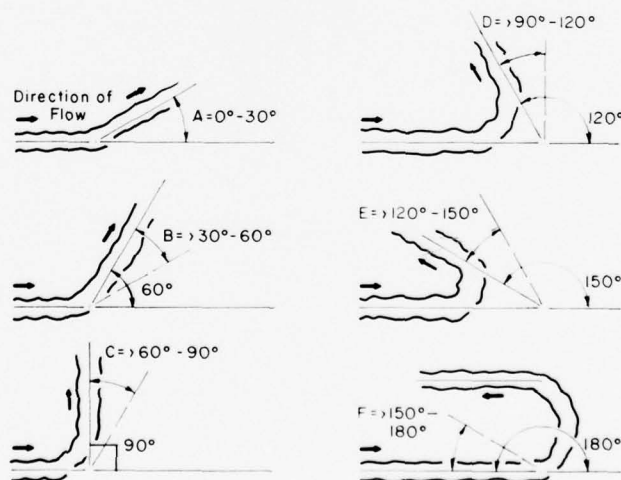
Figure 5. Meander classes.

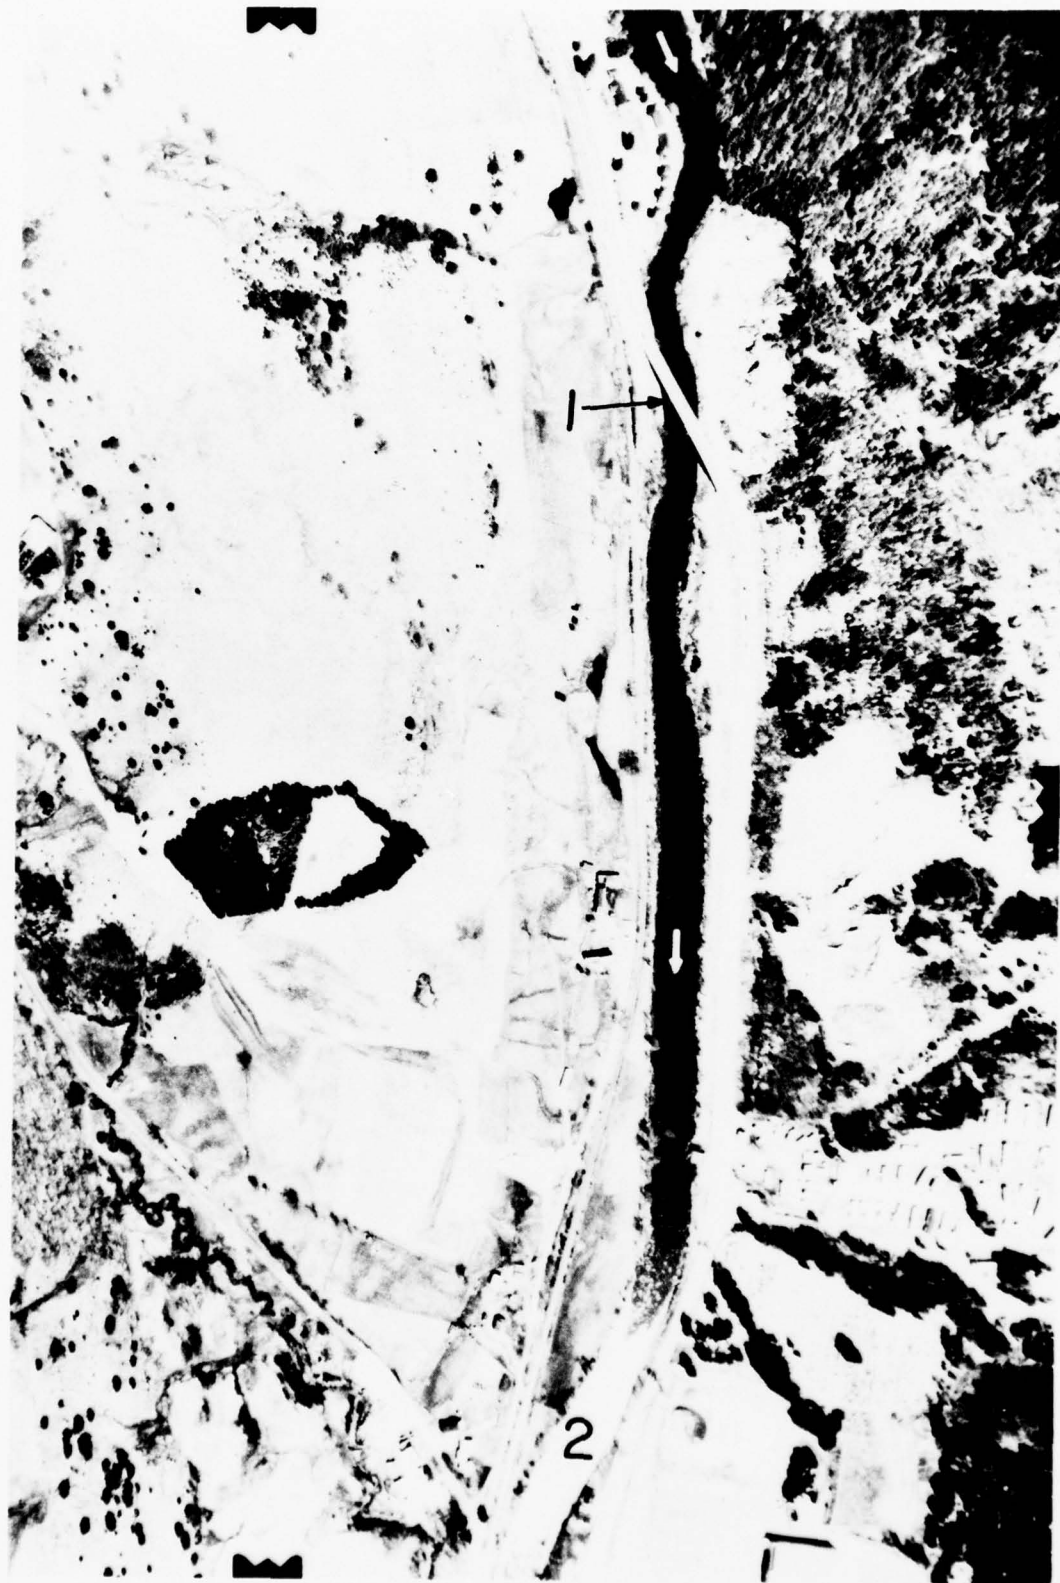
Figure 6. Northern end of St. Johnsbury site, Reach A. Scale: 1 in. = 483 ft.

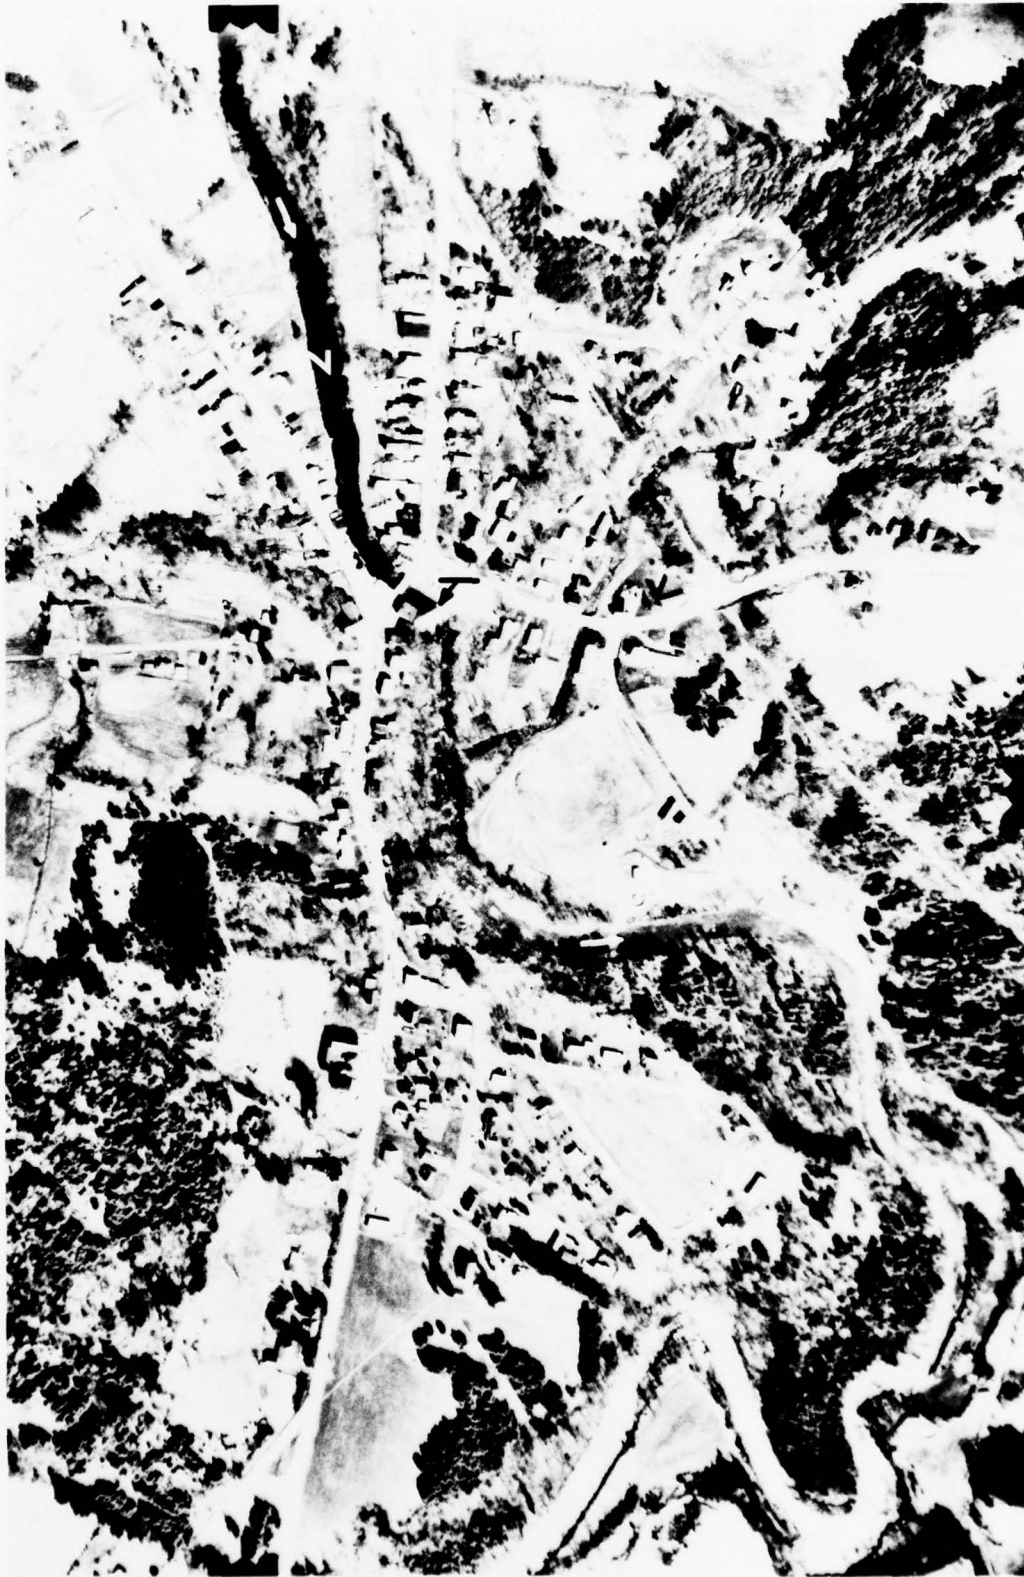
Figure 7. Winooski River, upstream from usual ice jam site shown on photomosaic 9. Features shown here are typical of those in the study site. Scale: 1 in. = 439 ft.

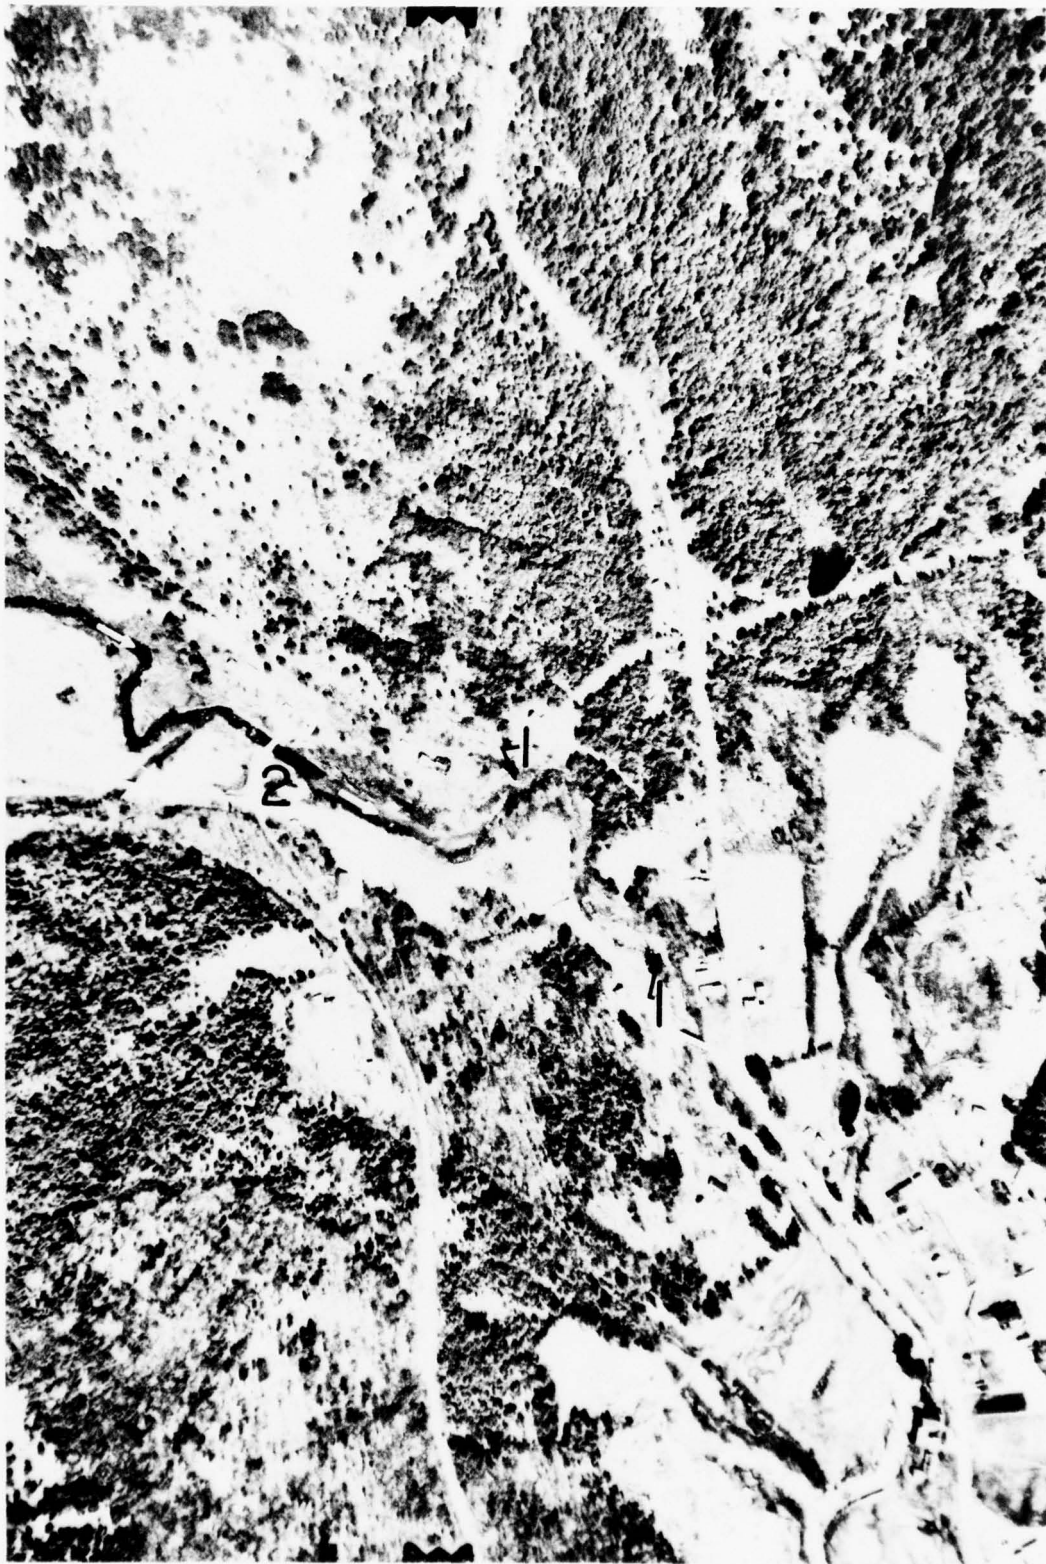
Figure 8. Groton site, photomosaic 10. Scale: 1 in. = 441 ft.

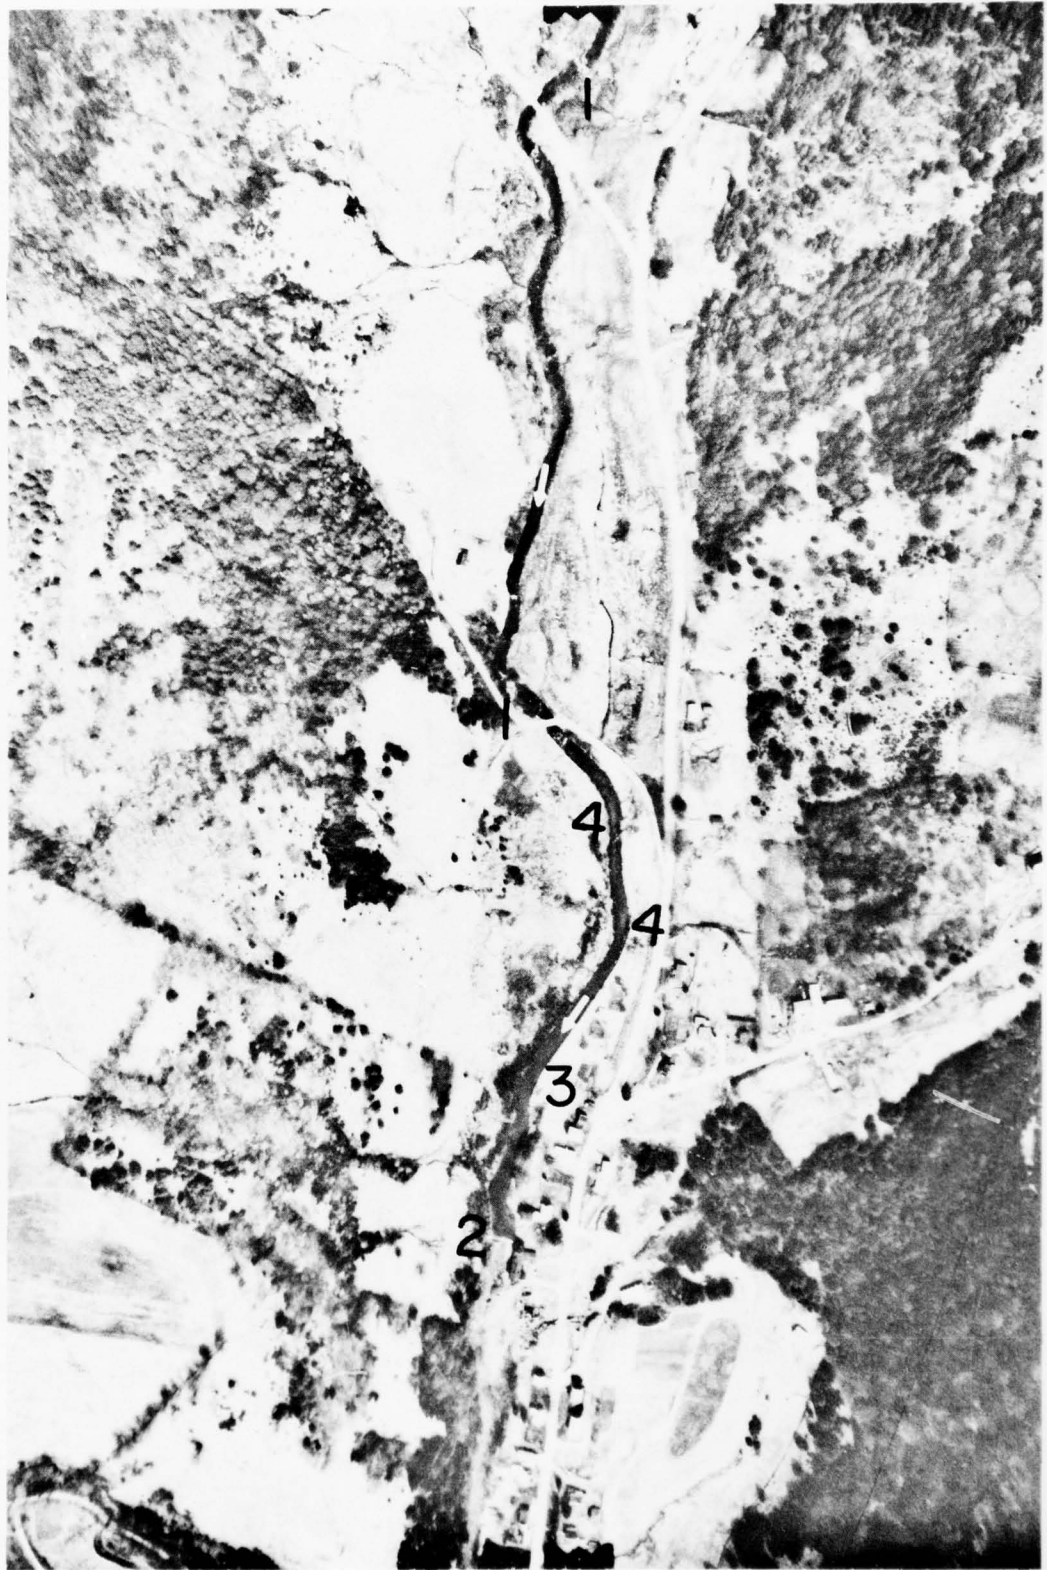
Figure 9. Tabor Branch of Waits River, upstream of the study site. Scale: 1 in. = 563 ft.

Rapids (1), a dam (2), and a dam pool (3) appear in Figure 9. The dam pool obscures much of the detail of channel roughness that is evident downstream from the dam, although shoals and riffles with surface waves are faintly observable at the light areas (4) in the water.

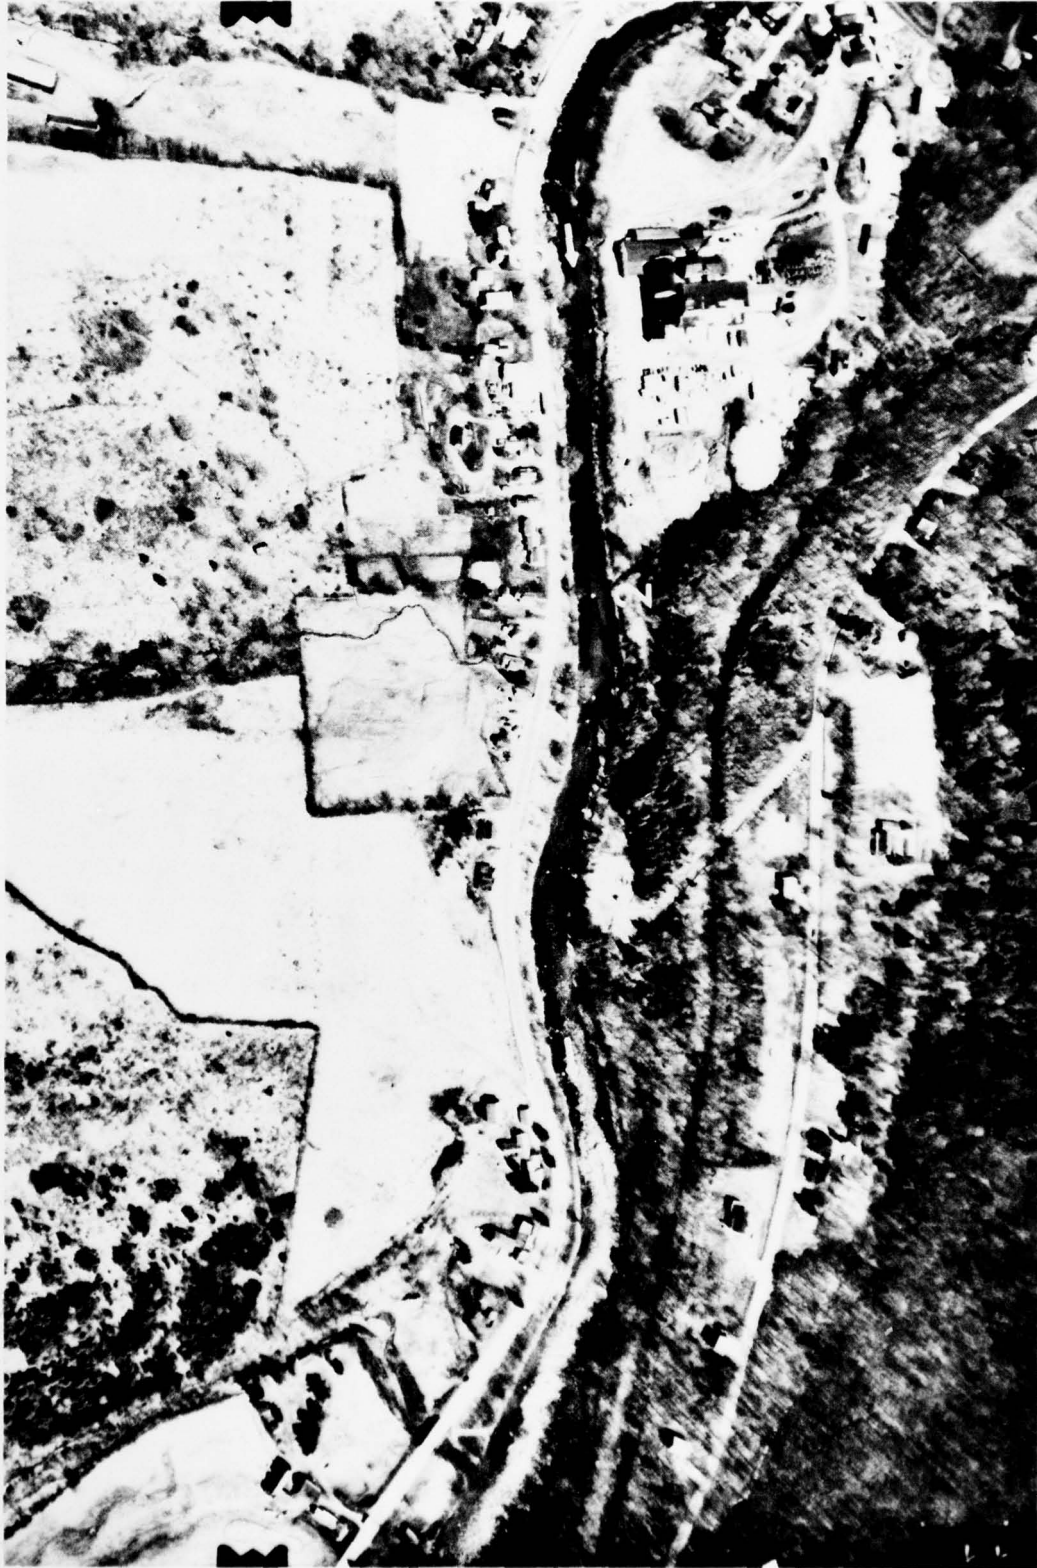
Figure 10. Downstream end of Wilmington site, photomosaic 16. Scale: 1 in. = 381 ft.

At the Wilmington site (Fig. 10) the appearance of a large confluence (1) is illustrated. Ice entering the main river from a tributary may add enough ice volume to the main channel to contribute to the formation of an ice jam. Within each site the number of major tributary confluences was counted (Table III). Small confluences (2) (Fig. 10) were not counted, since the amount of ice contributed to the main channel

was probably insignificant. The coarse texture of the bed material is apparent as shown by the many exposed rocks in the channel and by the boulders (3) along the shore. Sun glint obscures the surface water detail on the downstream side of the photograph (Fig. 10).

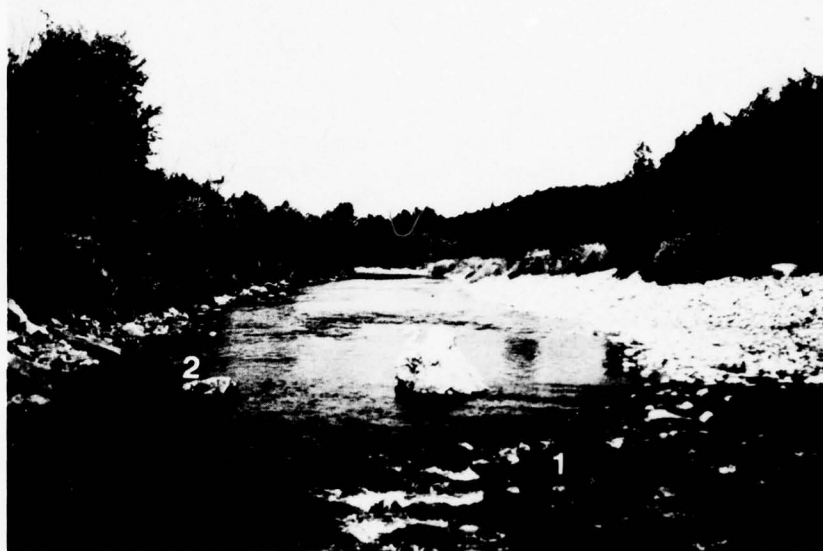
Figure 11. Channel at Hardwick site looking downstream. Riffle (1), channel rocks (2), coarse channel material (3). (Photo, courtesy of S. DenHartog).

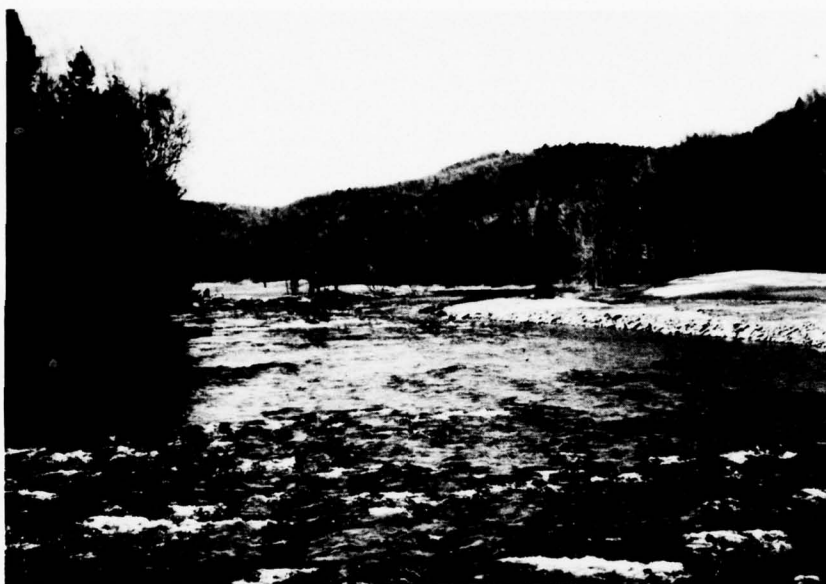
Figure 12. View upstream on the Ottawaquechee River from upstream point 3 on photomosaic 18. Rapids in foreground and center are shown on photomosaic. (Photo, courtesy of D. Calkins).

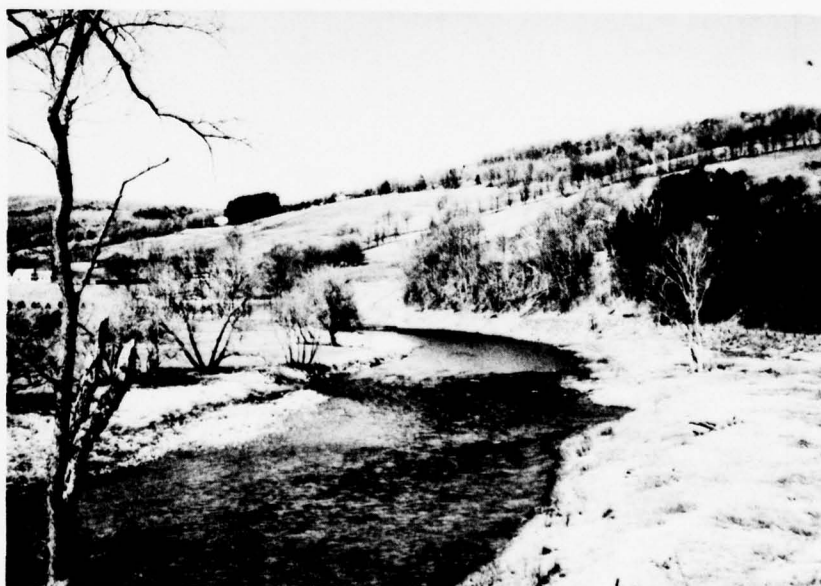
Figure 13. View upstream on the Ottawaquechee River from point 5 on photomosaic 18. Note riffle in center and coarse material on the bar. (Photo, courtesy of D. Calkins).

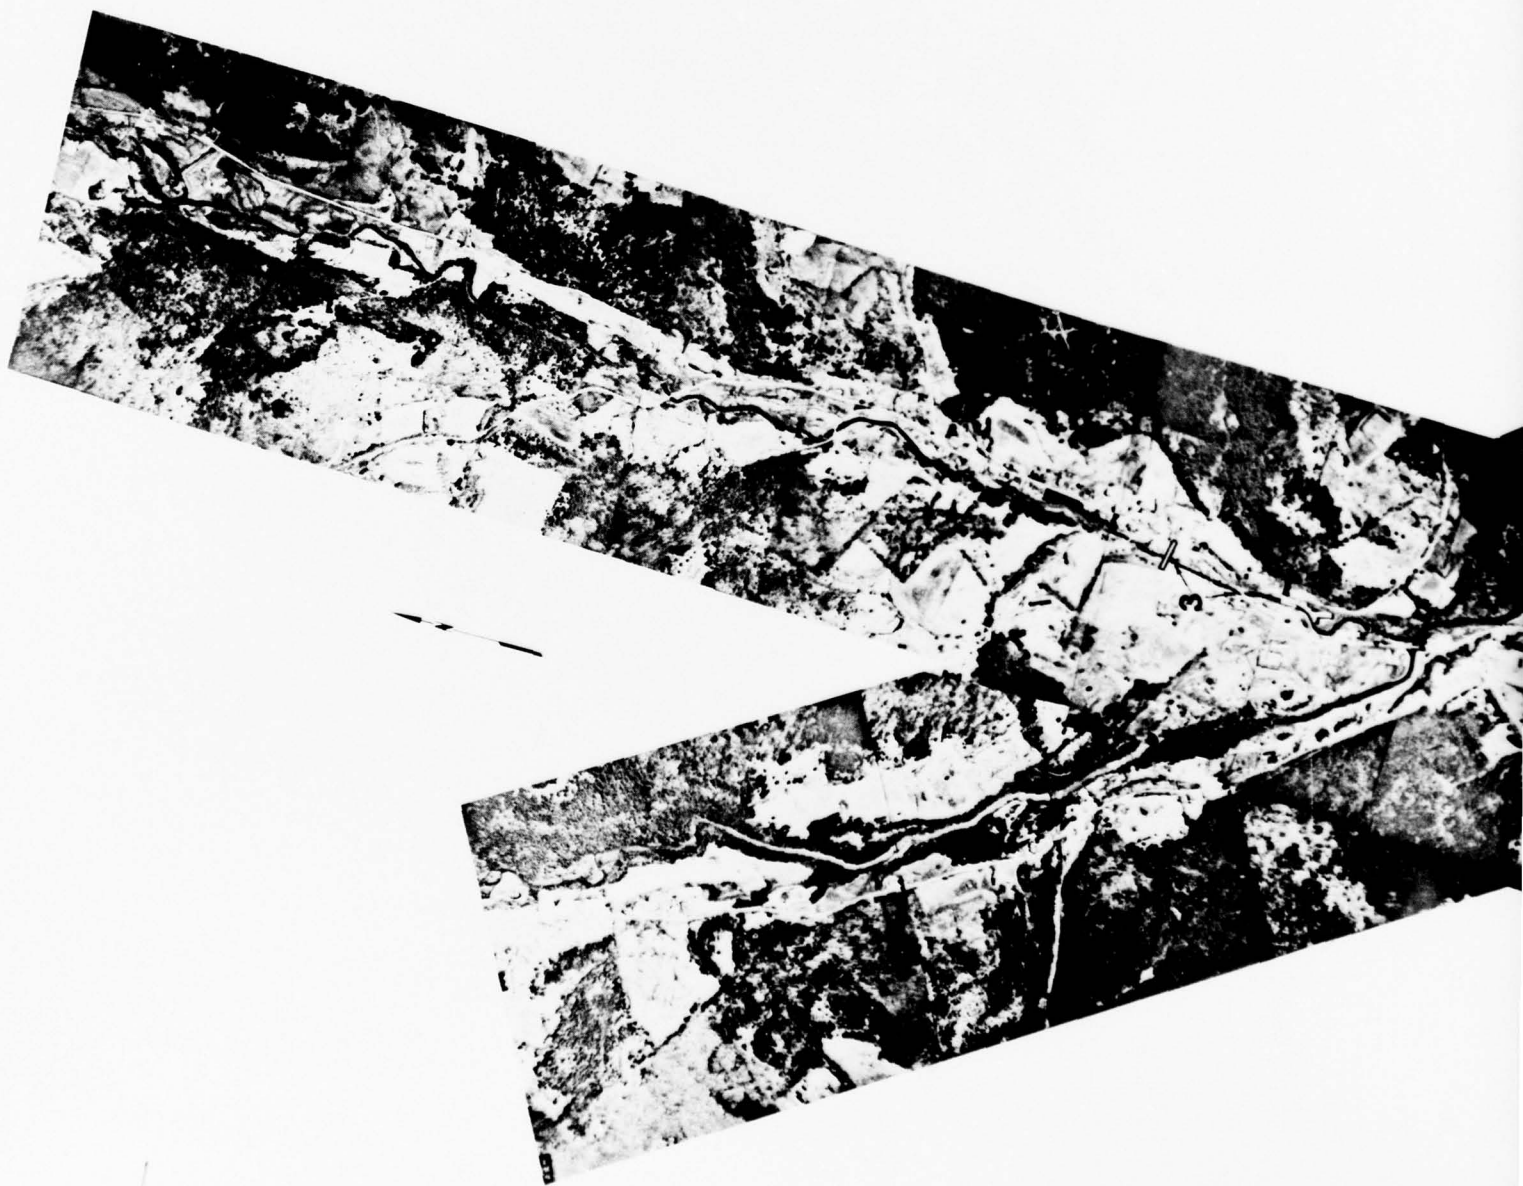
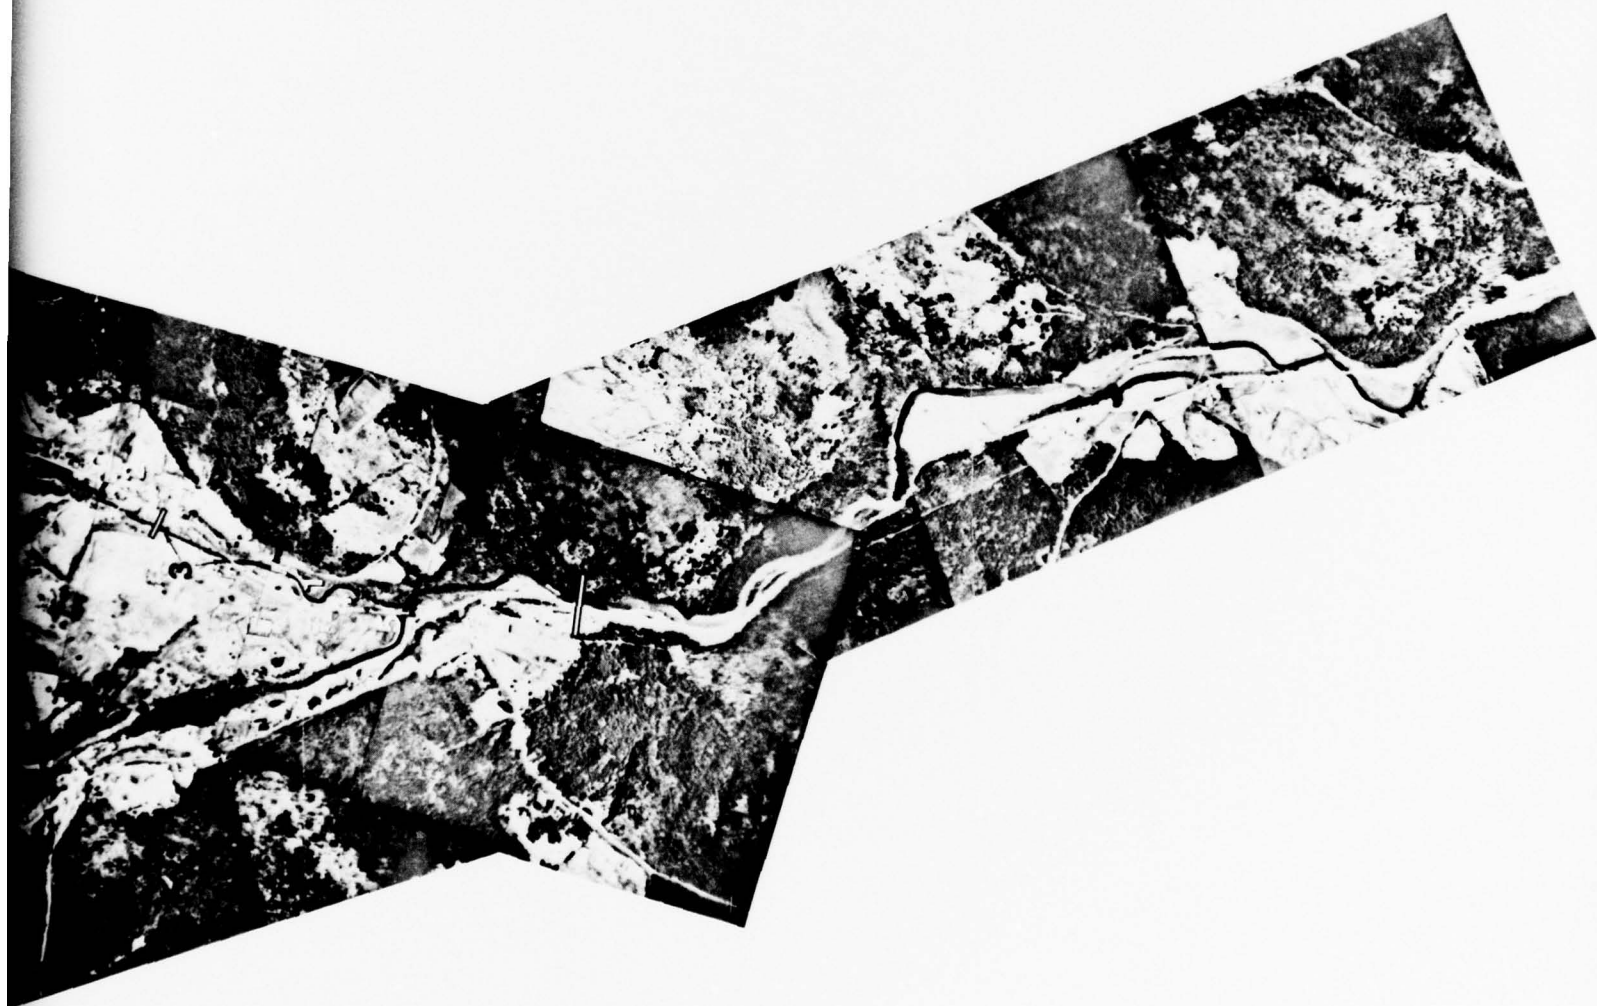
Figure A11. Waits River, East Corinth, Vermont,
21 April 1976. Original scale 1 in. = 563 ft; $\frac{1}{4}$
original size.

Ice jams typically occur at the confluence of the Waits River and Tabor Branch (1) near East Corinth (2). The channel is steepest along the Tabor Branch, and it is shallow. Pools along the Waits River portion are usually small and not too deep. The channel widths along the Tabor Branch vary from approximately 30 to 50 ft, and widths increase to 75 to 110 ft along the Waits River. Ice jams have formed along the Waits River at the bridge (5) near the confluence and have caused ice flowing down the Tabor Branch to stabilize and back up the Tabor.

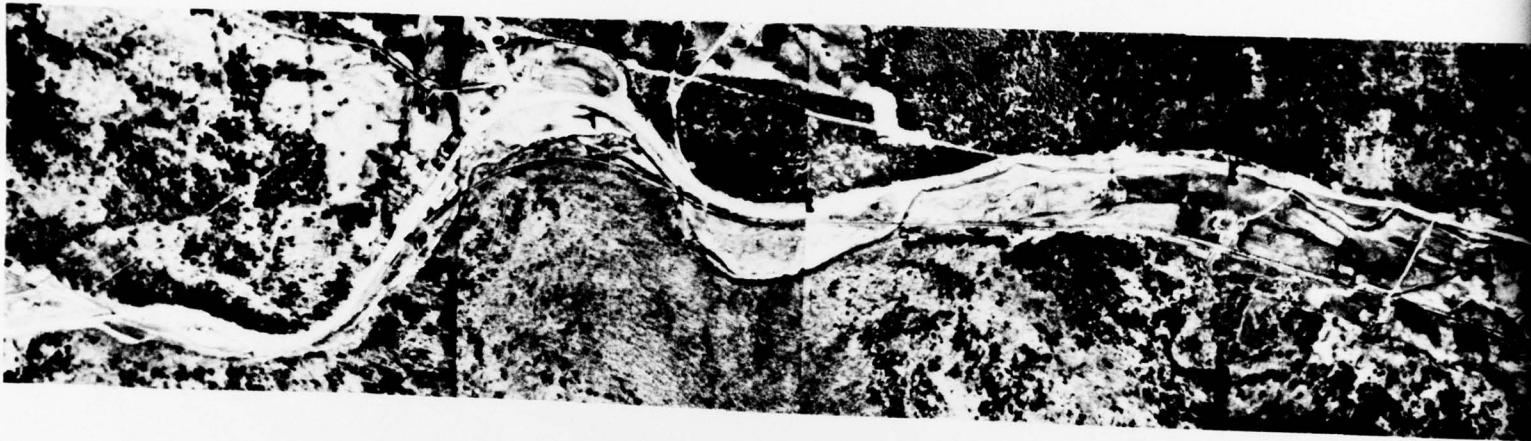
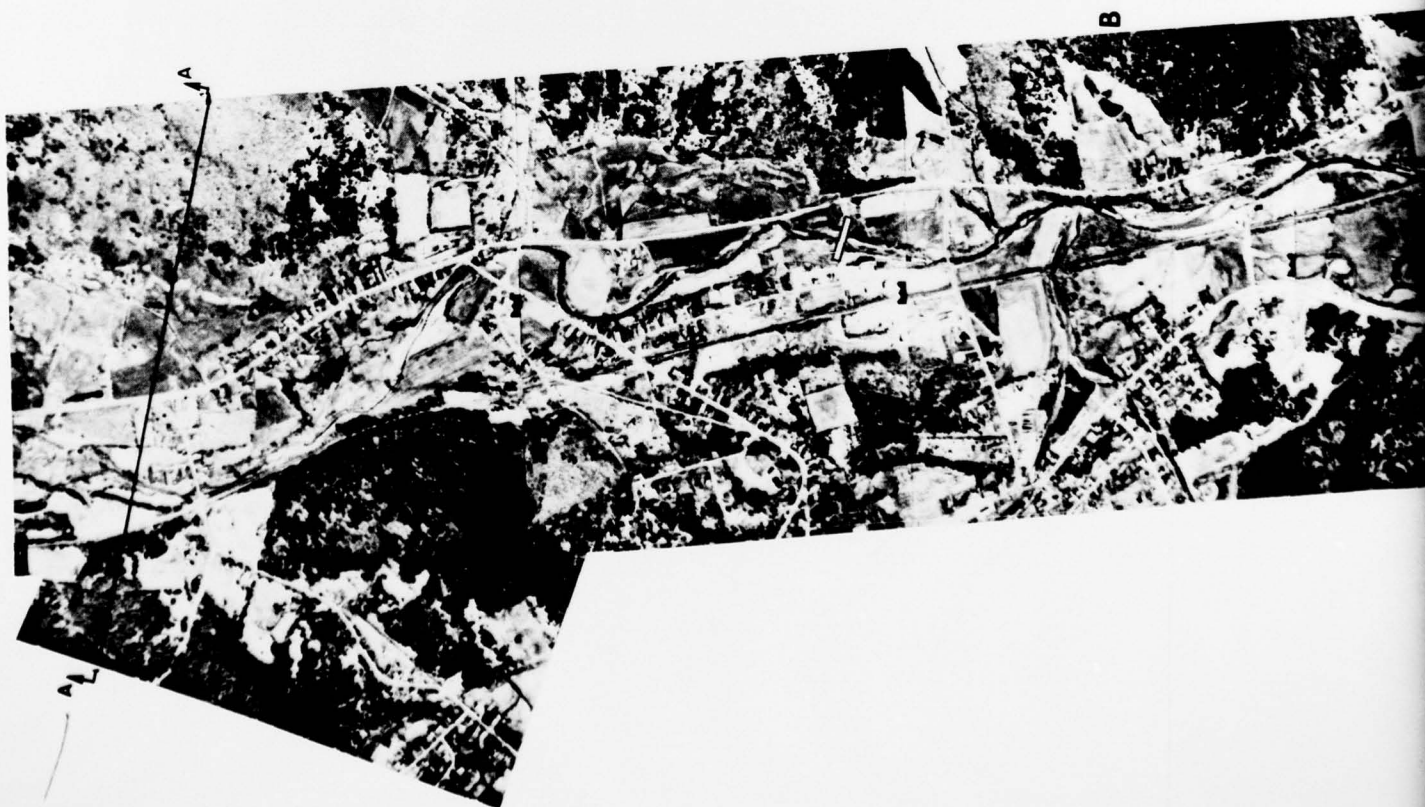
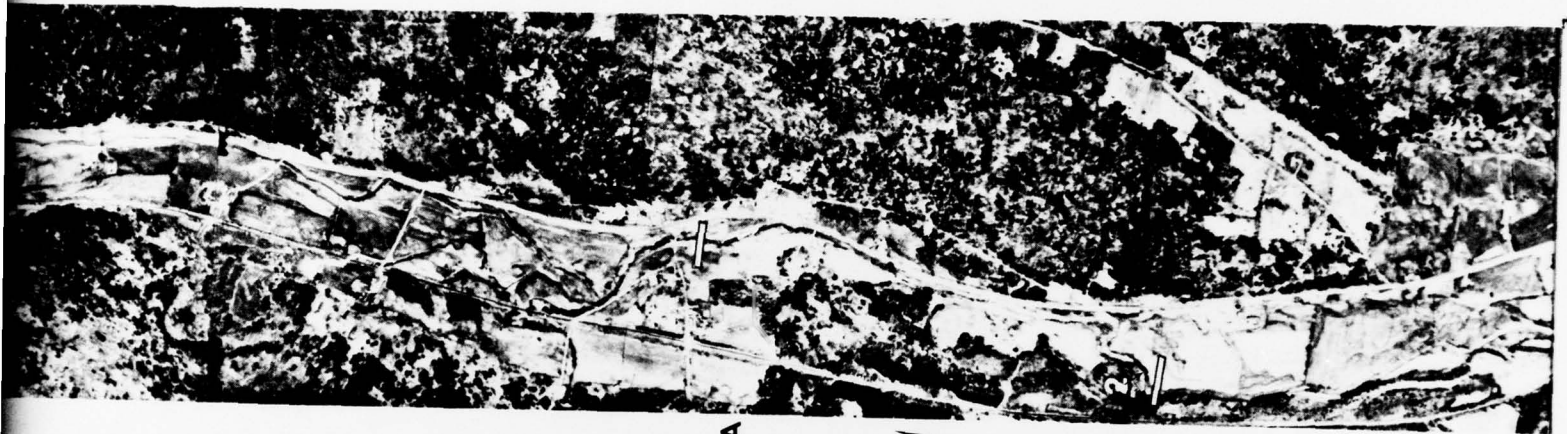
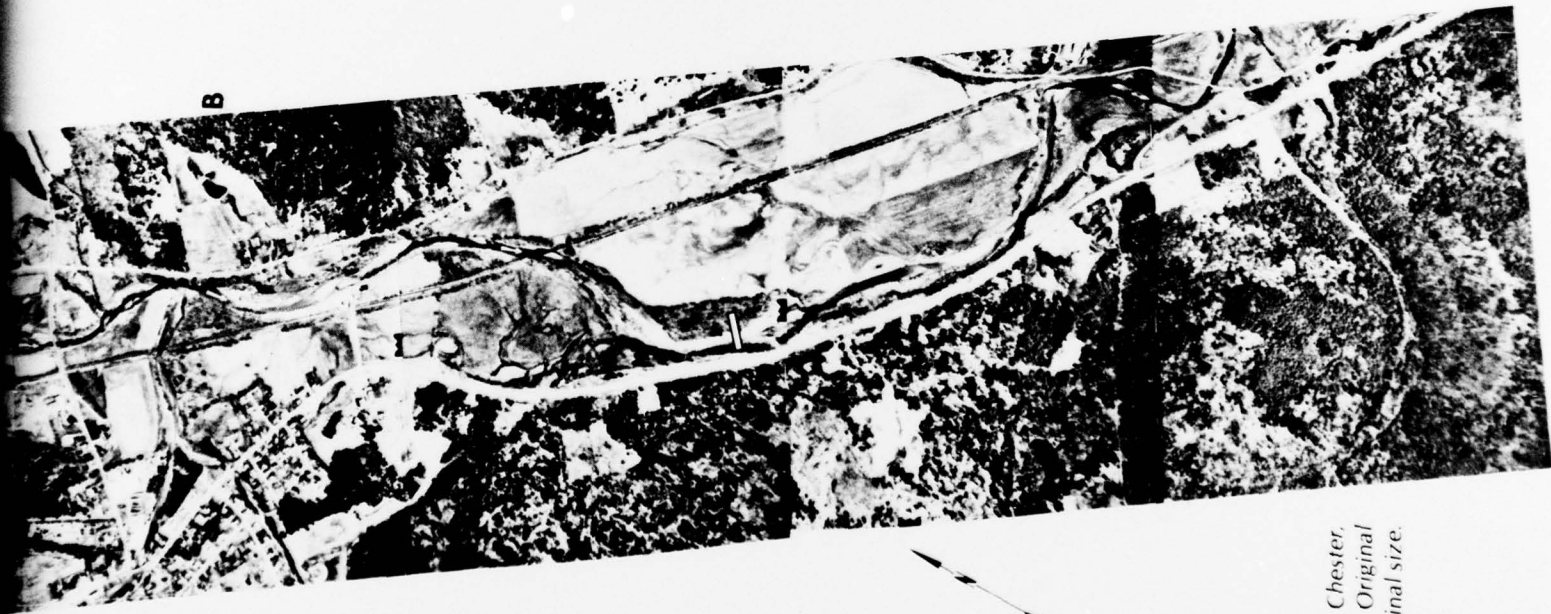
Figure A17. Williams River, Chester, Vermont, 21 April 1976. Original scale 1 in. = 487 ft; 1/3 original size.

There are two reaches along the Williams River near Chester where ice jams typically occur: Reach A is 1.5 miles north of North Chester (point 1 on Reach B), and Reach B extends from Chester 1.3 straight line miles downstream. Along Reach A, one pool (2) is apparent; the remainder of the reach is a riffle. Exposed rocks are common and rapids are small. Channel widths (Table BI, App. B) vary from 20 to 50 ft. The floodplain is wide (about 1100 ft) and marshy (3) on the west central side. The meanders and the meander bars at the southern end, and the shallow water, may be the primary factors that initiate the ice jams.

The channel along Reach B appears to be deeper than that along Reach A and has several mid-channel bars and large, well developed meander bars. Channel widths vary from 25 to 110 ft. Although riffles and shallow pools are apparent, most of the channel is shallow. Channel bottom material appears coarse [note the exposed boulders and the coarse appearance (4)]. The floodplain width varies from 2000 ft at the south end to 1000 ft in the middle. The mid-channel bars and bridge may be the controlling factors causing ice jamming.
